Consolidation a Mud-Brick Tomb against the earthquake: An Experience from Ardakan, Iran

Keywords: Consolidation, Tombs, Mud-brick, Earthquake

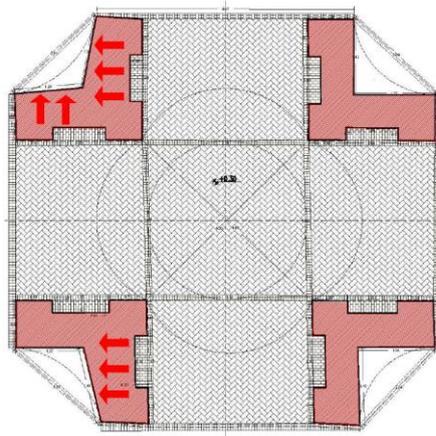
As shown in ‘Fig. 3’, the main columns have drifted due to the lack of a tensile element or backing in two positions, including west and southwest. In other words, the western side has projected more than 10 cm. This drift has caused vertical cracks in the legs of the arches on the north and south sides and dome as shown in ‘Fig. 4’. Controlling this drift and correcting the geometry should be one of the priorities of the consolidation plan.

Figure 3. Drift diagram and

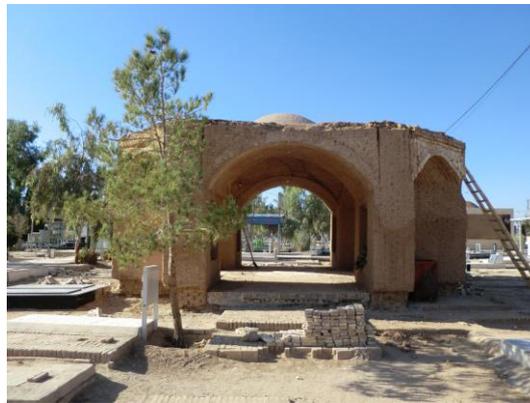
Figure 4. Cracks in the legs of the arches and under the dome

Hollow spandrels (Konu) have been broken due to drift. They should be removed from the arch surface and reassembled.

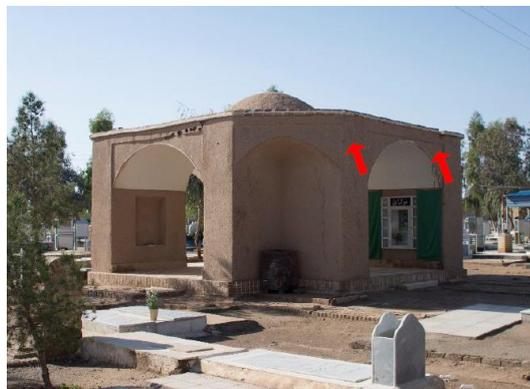
Most surfaces of the building are covered by a cob layer that has been spoiled in many places due to the presence of termites. This issue has caused the possibility of falling off the eaves on the north as shown in 'Fig. 5'.

Figure 5. Possibility of falling off the eaves on the north

To kill the termites, holes were dug into the floor and walls, and then poison was injected into the holes as shown in ‘Fig. 14’.

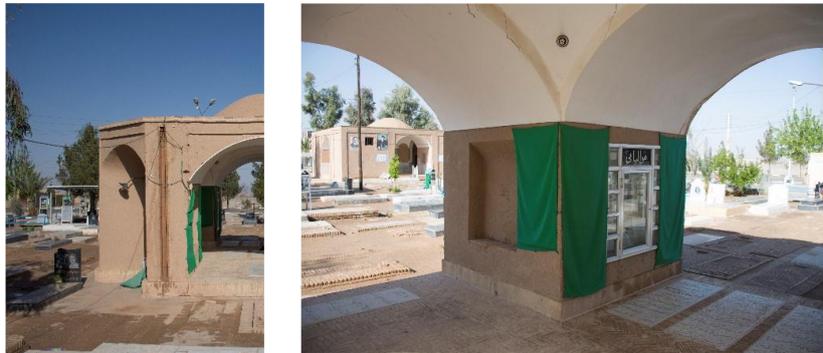
The exterior of the building has a 20 cm plinth of brick, which is executed in the form of a porcelain vein brick, and from the inside, square bricks have been added later. The plinth inside the building is very weak and has been damaged in different places as shown in 'Fig. 6'.

Figure 6. External and internal plinth

As seen in ‘Fig. 15’, 60 cm plinth was executed using bricks inside and outside the tomb.

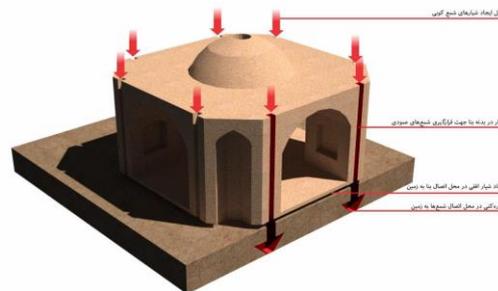
Based on the stratigraphy of the basement of the building, it was revealed that the building does not have a solid limy or stone foundation. Its main reason was the existence of many graves adjacent to the tomb. Since the presence of lime accelerated the corruption of corpses and is not correct according to Islamic law, the architect had to not use the lime. Furthermore, the columns of the building were located on old graves which has led to the looseness and emptiness of the soil under the columns.

Figure 7. Simulation of vertical load path

As mentioned earlier, this building has no foundation. For preventing further subsidence, it is necessary to use vertical wooden piles that connect the structure to the ground. According to 'Figs 7 and 8', eight grooves were created in the eight corners of the building.

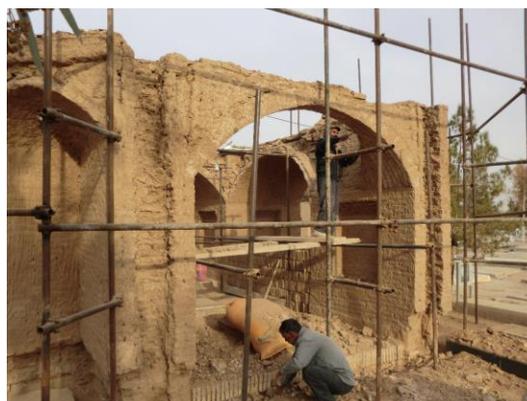
Figure 8. Wall grooving

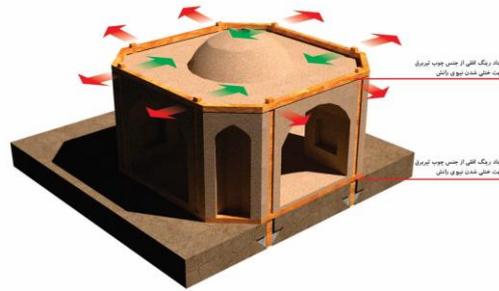
Figure 9. Simulation of lateral load path

As seen in 'Fig. 9', posts were embedded in the eight grooves and dipped into the ground at a depth of 1 meter. Also, a hole for each pier foundation was dug and they were filled with lime mortar. Old electric poles that have high resistance to rot and termites were used as the post. To control the drift, the posts should be jointed in two parallel rings, a plinth beam on the floor level and a tie beam on the roof using wooden beams. This type of joint acts like a tie. Date palm fibers

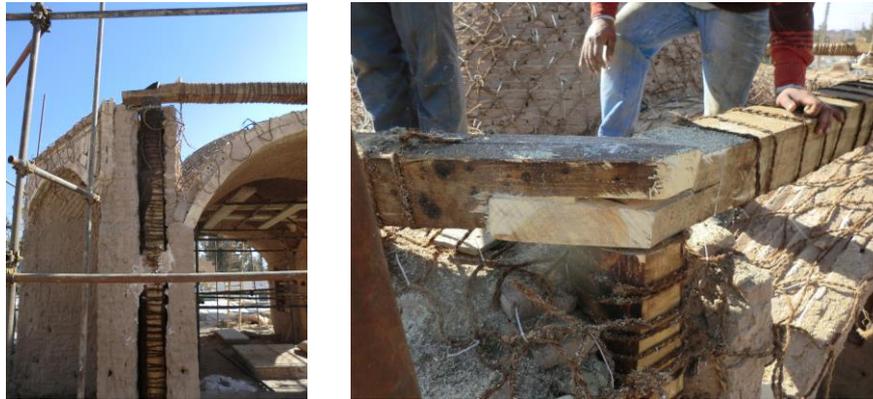
Figure 10. Embedding the posts in the grooves and jointing them to the beams

were wrapped around the posts and beams so that they have a better connection with the structure and the joinery, as shown in ‘Fig. 10’.

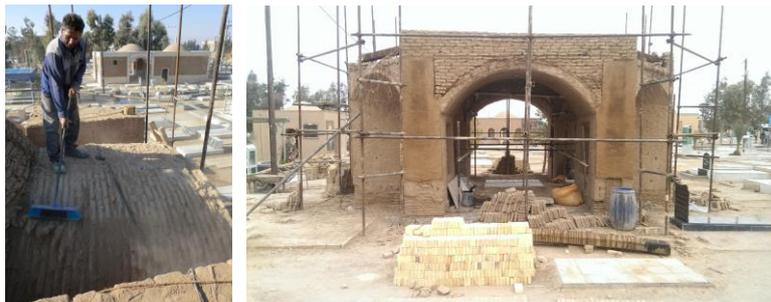
Figure 11. Removing the hollow spandrels and reassembling them

The hollow spandrels have been removed from the arch surface and reassembled as shown in ‘Fig. 11’.

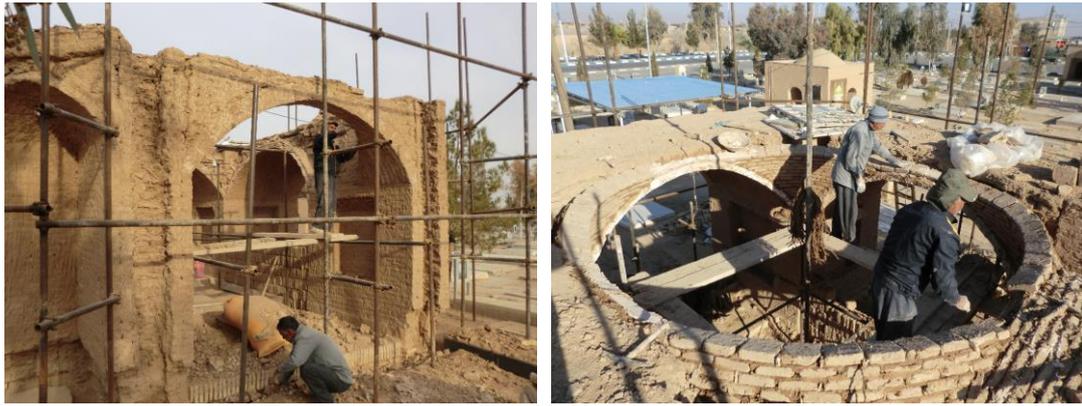
Figure 12. Removing the old dome and rebuilding the new one

Due to the subsidence, structural cracks had been created in the dome of the tomb. Thus, the dome had to be removed. A new dome was rebuilt with the remaining mud-bricks as shown in ‘Fig. 12’.

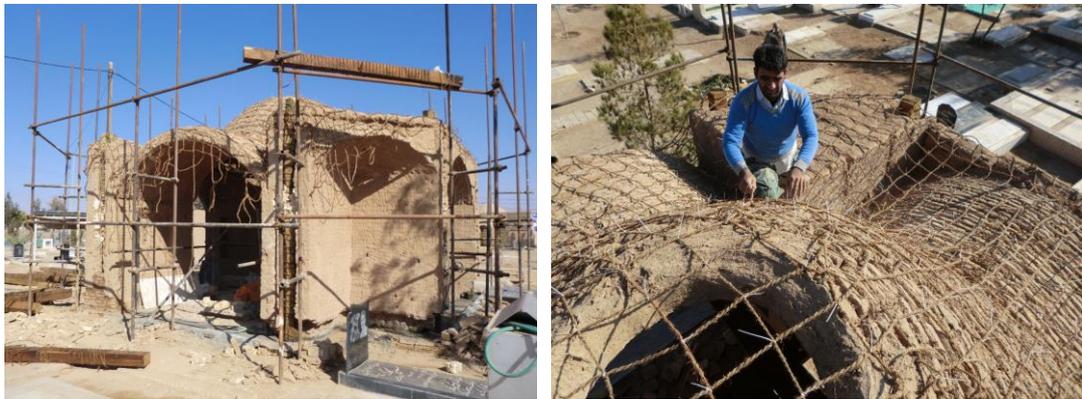
Figure 13. Removing the old dome and rebuilding the new one

In order to integrate the building components, the roof was covered with a net of date palm fibers as seen in ‘Fig. 13’.

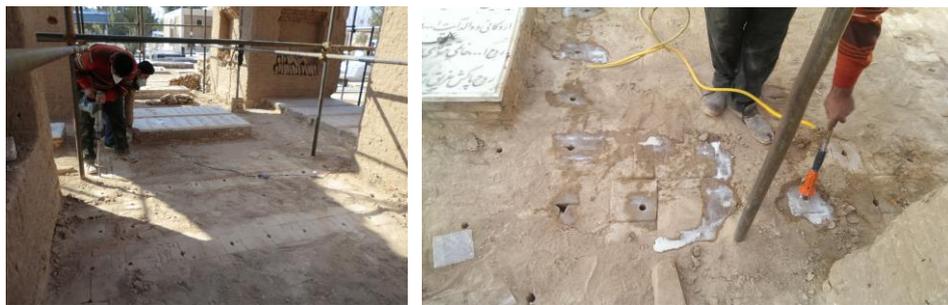
Figure 14. Making the holes and injecting the poison

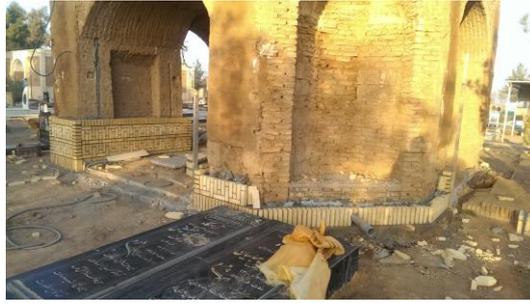
Figure 15. Executing plinth inside and outside the tomb
