THE ROOF REPAIR OF A BORANHANE

Assoc. Prof. Dr. Şefika Ergin, Berfin Aydınalp,
Berhat Yakut
Faculty of Architecture, Department of Architecture
Dicle University, Diyarbakır
erginsefika@hotmail.com

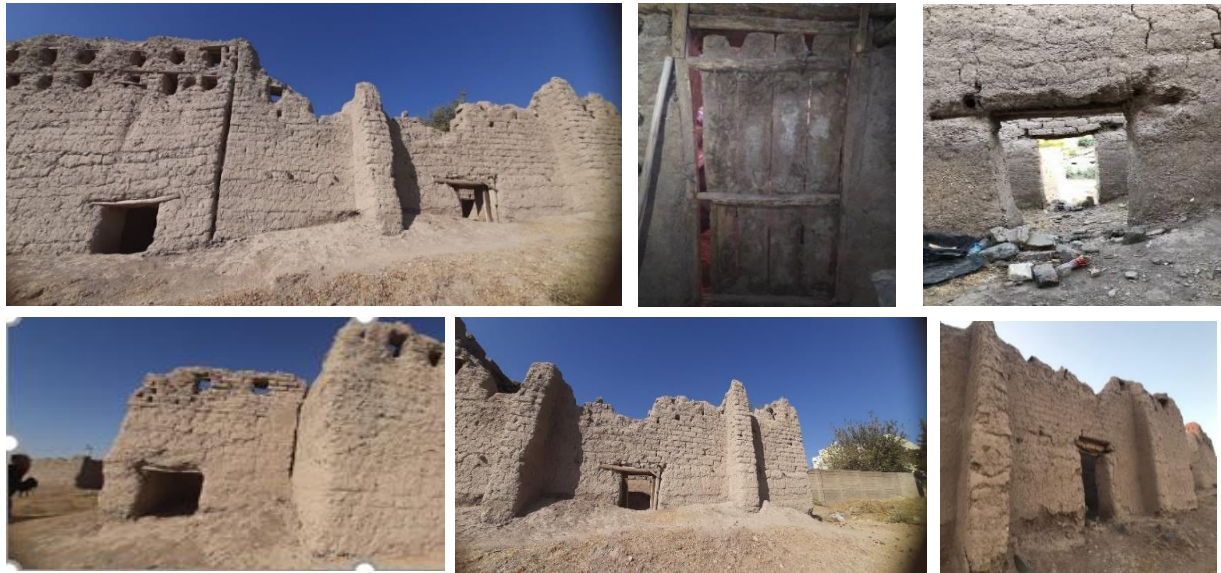
In the shelters, there are small doors open temporarily, once a year, which let people enter to gather the fertilizer. The height of the entrance door is approximately 99 cm (Figure 2). After people take the fertilizer, the door is closed by using adobe. Boranhane is planned as one part or 2-3 parts connected (Figure 3-4). Local people called these parts “lüle” (Bekleyen,2007).

Fig 2. Boranhane doors.

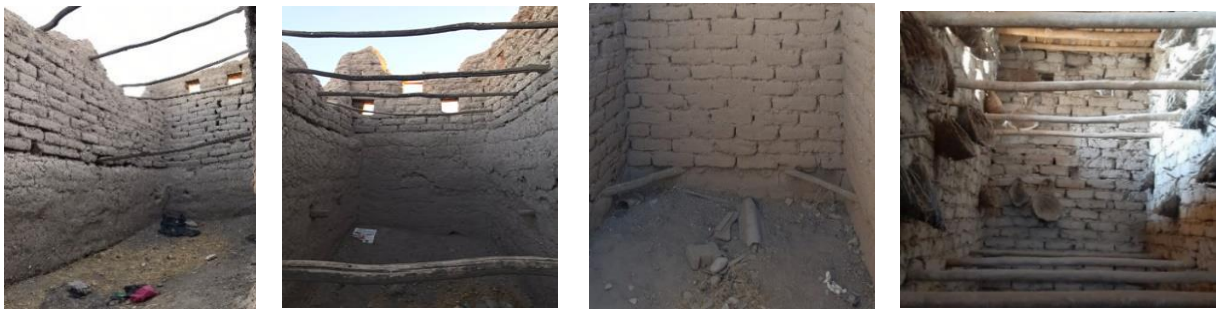
In boranhanes in this region has wooden stakes on their long walls inside. The diameter of those stakes is in the range of 10-15 cm. Also, they are placed at two different heights changing between 130-200 cm (Figure 5). The first level of height is in the range of 130-160 cm and the second level of height is in the range of 215-300 cm. Those wooden stakes increase the strength of construction and they are used to hang baskets (Figure 6). Also, to let pigeons enter and exit the shelter, approximately 30 cm under the roof made by soil, holes whose sizes are 25x25 or 25x30 are built (Figure 7). Their façade is plain and there are many holes (Figure 8).

Fig 5. Wooden poles

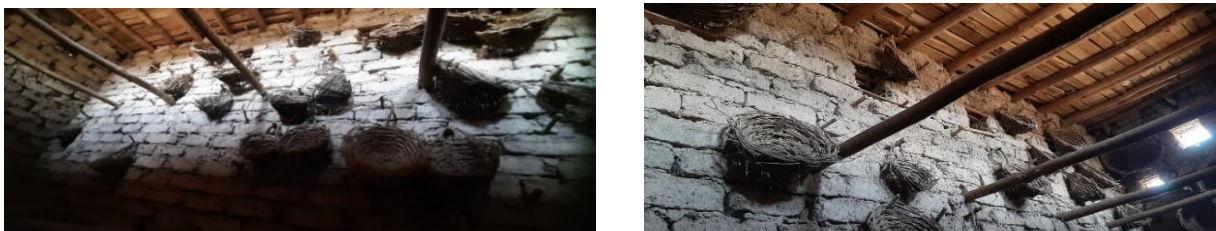
Fig 6. Baskets suspended on wooden poles

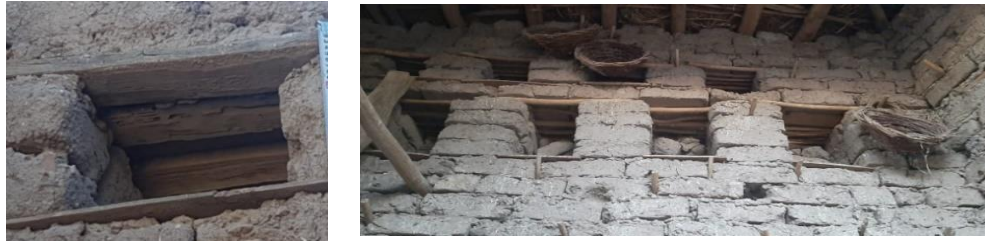
Fig 7. Spaces left for the entry and exit of pigeons

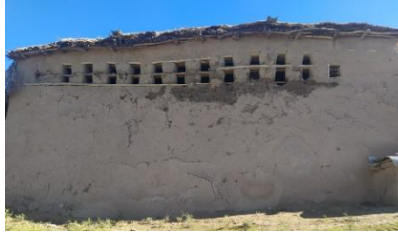
Fig 8. Boranhane facade (Drawer:Melek Geçirgen)

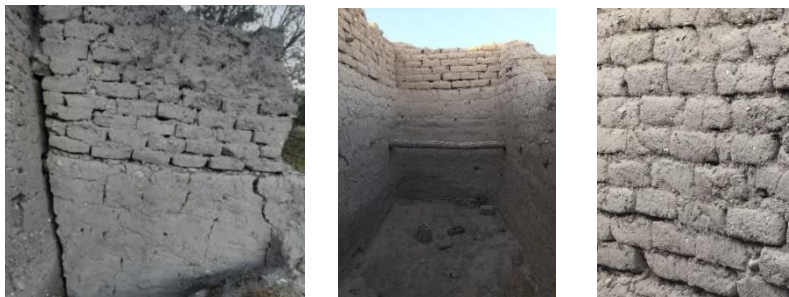
The walls of boranhane in Erimli and Karaçalı neighbourhoods in Diyarbakır are made of adobe. The thickness of the walls is in the range of 50-55 cm. Adobe is compressed and built with cast adobe 80-100 cm above the ground (Figure 9). 35x15x10 cm adobe blocks were made on the cast adobe.

Fig 9. Wall mesh system

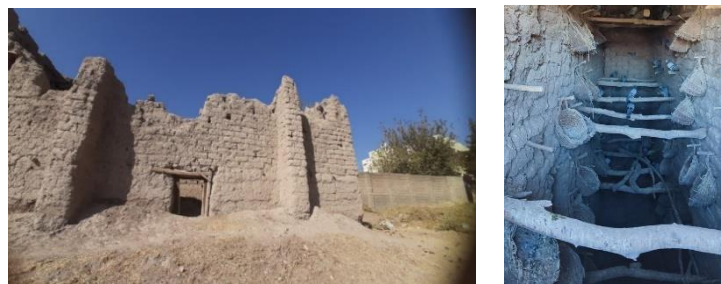
The height of floors generally falls between 3.5 and 5 meters. Also, to increase the durability of the walls, supporters are built from the inside and outside (Figure 10-11). The door which let the transmission between the parts has 10 cm lintel on the top of them (Figure 12). In addition, the roof of these structures are flat and made of soil.

Fig 10-11. External and internal support

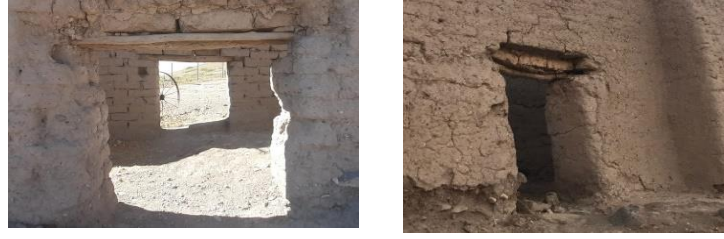
Fig 12. Lintel use

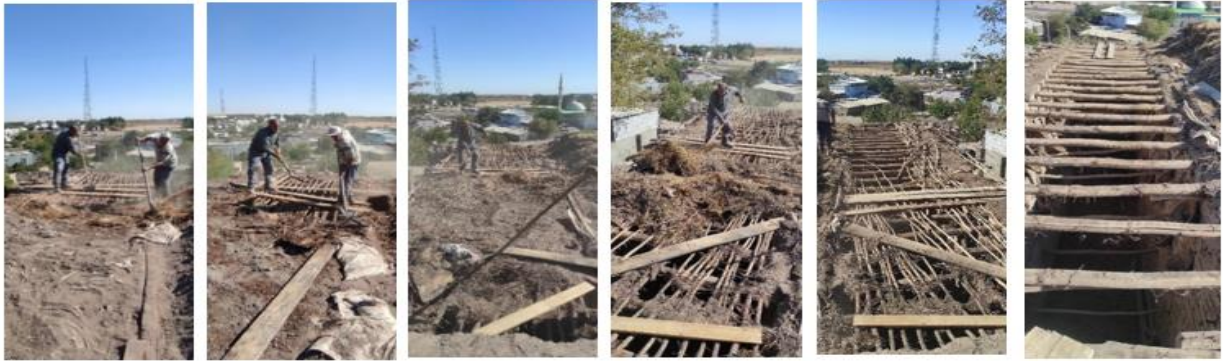
Before the restoration, the soil layer which constitutes the top layer of the roof is removed. It is observed that the linoleum which is placed under the soil layer and leads to water insulation is damaged partly over time and lost its ability to insulate. Because of these damages, linoleum and bushes under it are removed. Branches of trees that are under these layers are also completely removed (Figure 14). After removing the layers of the roof, the wooden carrier beams showed up. The beams which have corruption and cracks are detected and the highly damaged ones are renewed. To extend the short eaves distance, thick lumbers and main carrier beams are put together with nails. The distance of eaves is extended and more decent eaves are obtained. Also, the corner points of the eaves are strengthened by the woods. On the extended eaves, the lumbers whose length is 20 cm and whose width is 2-3 meters are nailed, and by doing so the top of the carrier is totally covered. The elements of the extended eaves are filled with mortar whose length is the same as the wall's and the top of the eaves is totally covered by the lumbers (Figure 15). By doing so, the flatter and the stronger ground is made. The linoleum that helps insulation and protects the soil layer from spilling on the place is nailed to lumbers and is immobilized. The reeds obtained from the basins of the region are placed one by one and smoothly in order to get a flat ground. Also, because reeds are harsh and sharp, the chaff is put on them to make them smoother. It is important to put the chaff evenly and completely on the roof to avoid the sharp parts of the reeds harming the linoleum. After the roof is covered completely with the chaff, 2 layers of nylon are put for water insulation. A soil local is brought from a hill that local people called "Tilalo". The soil is mixed with water and chaff thinner than the former and put on the nylon (Figure 16). The soil which is the top layer gets stuck approximately in 1 year. It is recommended that

Fig 14. Dismantling of the roof

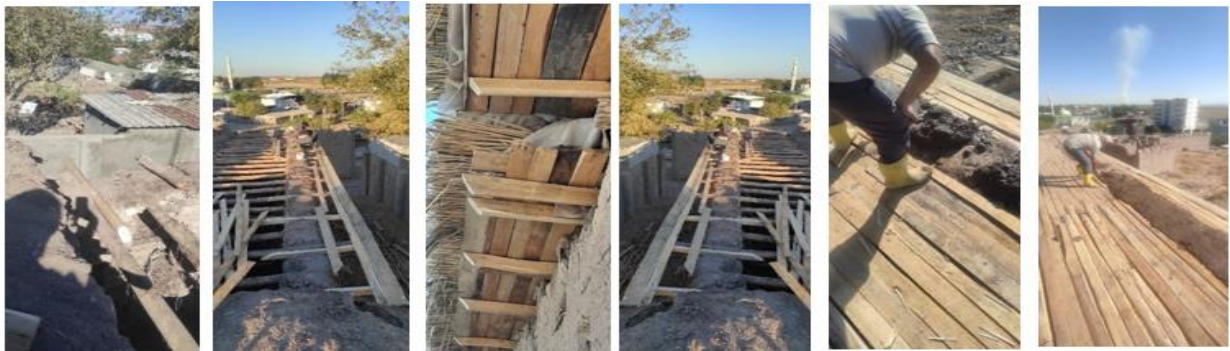
Fig 15. Regeneration phase

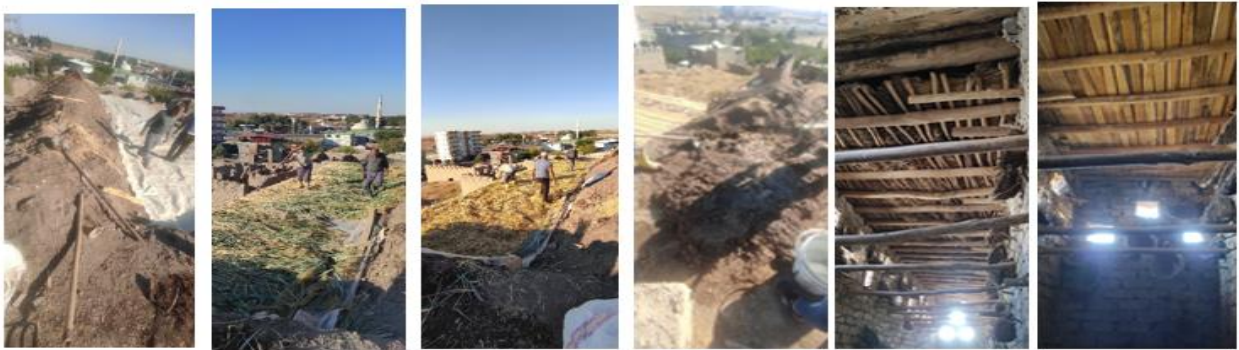
Fig 16. Completion phase

in dry seasons of that one year the surface of the roof should be made smoother by plaster mortar by the roofer.

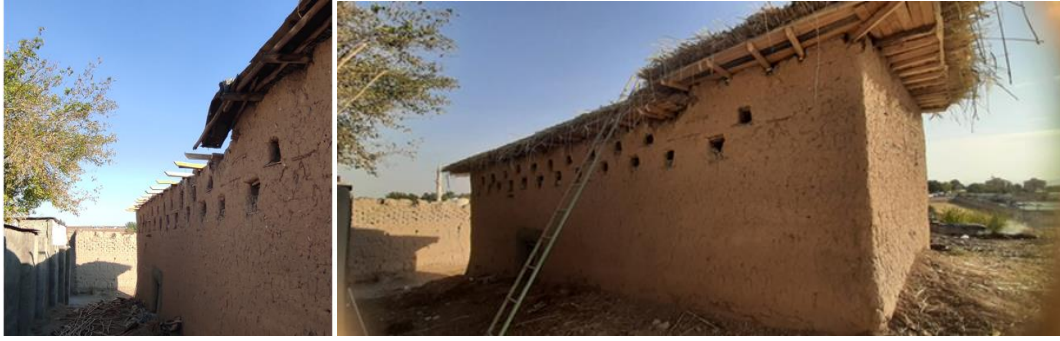
Fig 18. Condition before and after repair
