## **A study on Risks of Earthen Architecture due to Climate Change**

**Banu GÖKMEN ERDOĞAN**  
**Trakya University, Faculty of Architecture, Edirne**  
**banugerdogan@trakya.edu.tr**

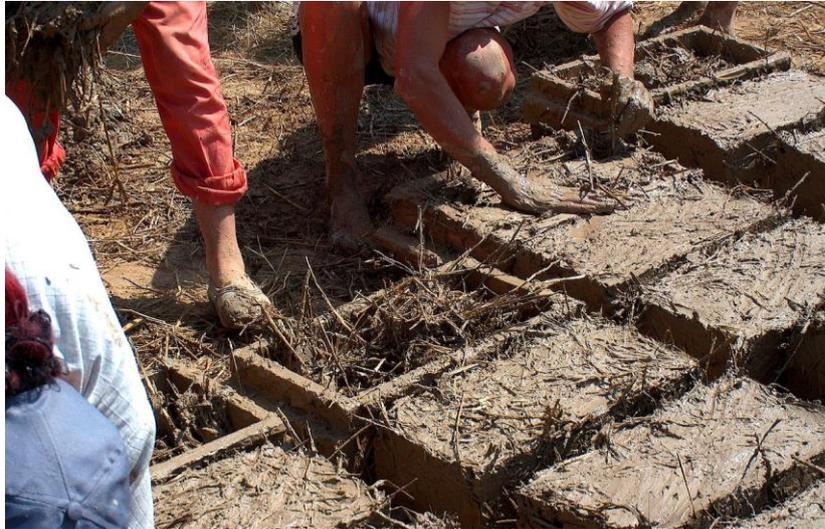
Figure 1. Adobe material [20]

The most common use of adobe material in buildings is construction with adobe blocks or compacted soil [17] (Figure 1). The building will have a long life, if the adobe material is kept for 2 years before being used in the building and the construction is done with appropriate techniques and methods [18]. In addition, the type of soil to be used in adobe material is important because the

Adobe material is sensitive to water and if necessary precautions are not taken, water penetrates into the material and starts the dissolution process of the binder clay. For this reason, rainwater washing the surface, water contacts due to insufficient drainage, flooding, rising ground water cause serious damage to the adobe material. However, sensitivity to the increase in humidity in the air and expansion and contraction mechanisms due to temperature changes are the properties that increase the vulnerability of the material to various factors [19].

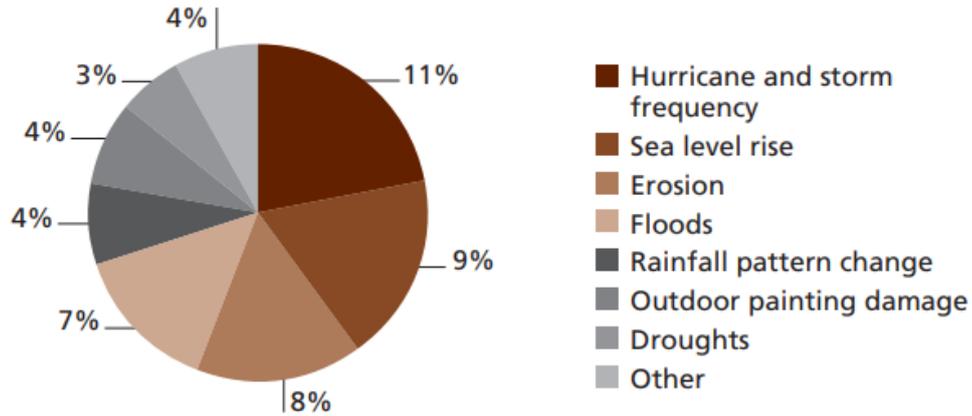
Figure 2. Threats of climate change for World Heritage sites [12]

Climate change has many negative effects in almost every field. Studies on their effects on cultural heritage generally examine climate indicators and the risks associated with them. The current threats posed by climate change on cultural World Heritage properties are defined as hurricanes and storms, sea level rise, erosion, floods, changes in precipitation regime, drought, etc. [12] (Figure 2).
