PALANGA GOAT SHELTER

Authors : M.Arch. Dilara Demiralp
Address : Beşiktaş / İstanbul 34349
E-Mail : demiralp.dilara@gmail.com

1. ABSTRACT

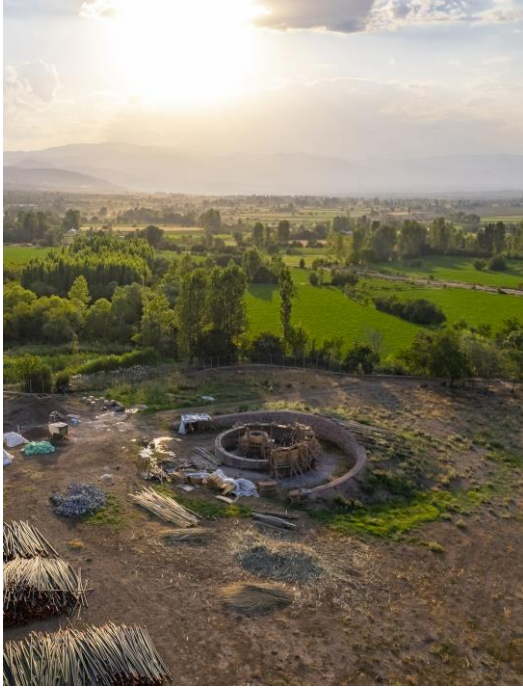
Figure 2. Aerial view of Palanga Goat Shelter during construction, *PAAF 2021*

Palanga Goat Shelter (**Figure 2**) designed within the framework of the requirements in PAAF and Erzincan; goat physiology, geographic attributes, local climate and seismicity. In a region where there is a shared earthquake memory based on the second strongest earthquake recorded in 1939 in Turkey. For this reason, it is of great importance that the structure to be proposed here is highly resistant to earthquakes.

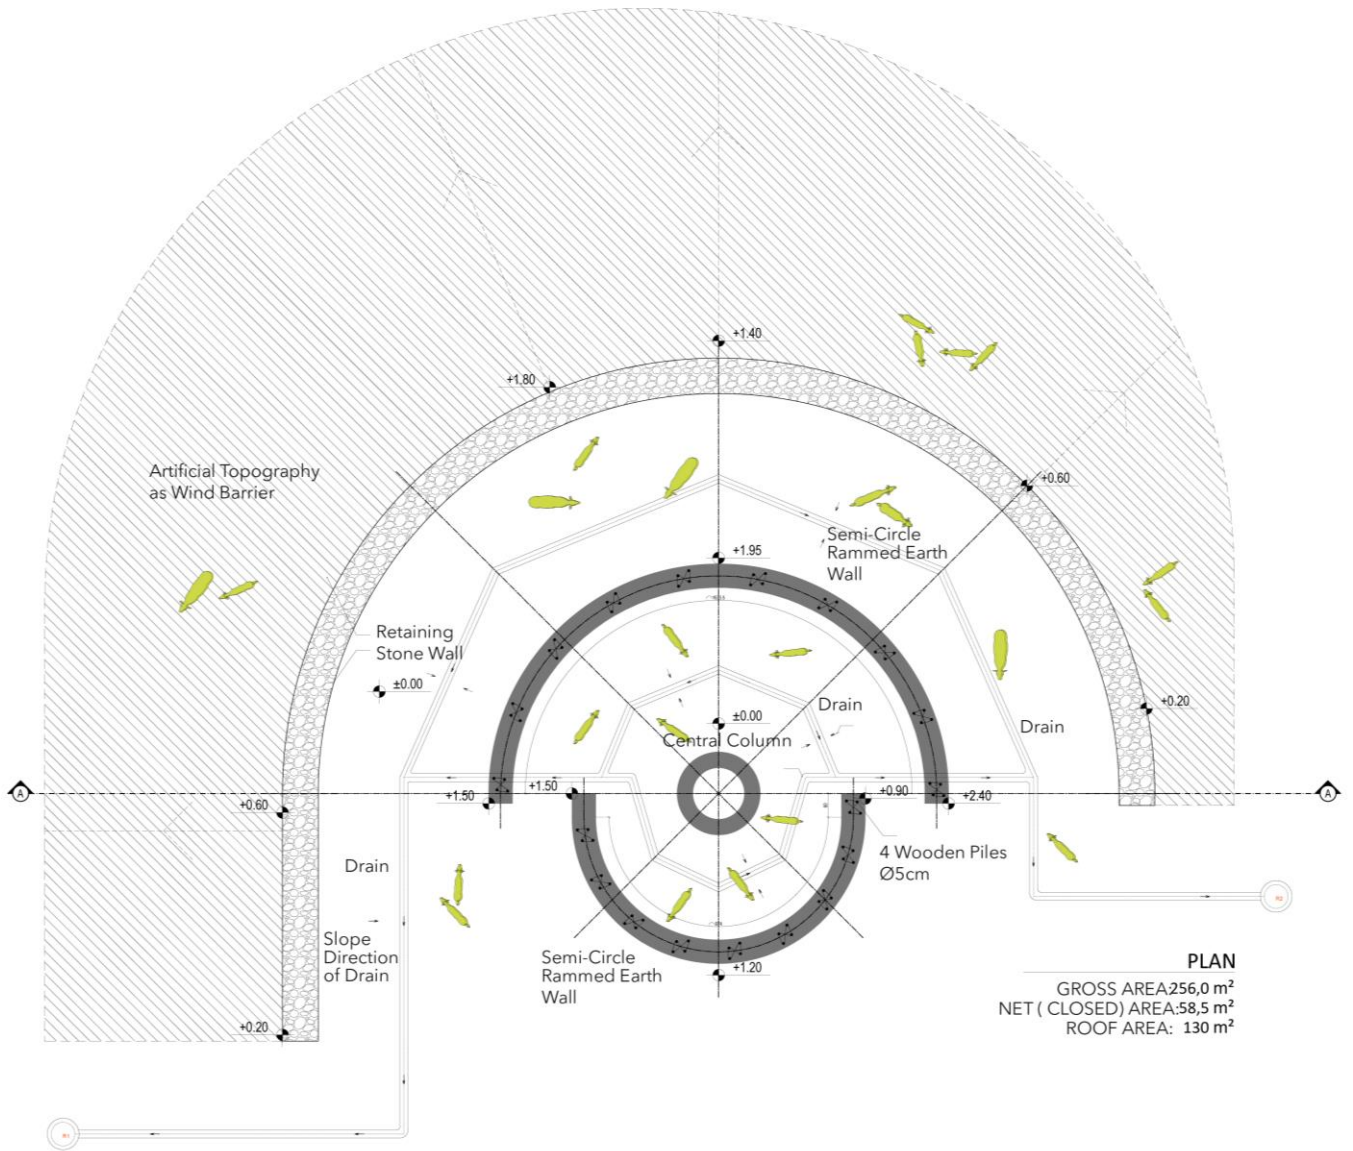
Figure 3. Floor Plan, *Dilara Demiralp, 2019*

The earth material near PAAF was tested for earthquake resistance before the construction. According to laboratory test results, the type with the highest strength was obtained. In order to obtain the required strength without using concrete, cement-free hydraulic lime is used as a binder in the stone foundation. After laying the foundations, in order to slow down and control the strong winds coming from the northwest, the construction process continued by creating a wind barrier with pile of earth that rose and damped in a curvilinear direction around the shelter walls.

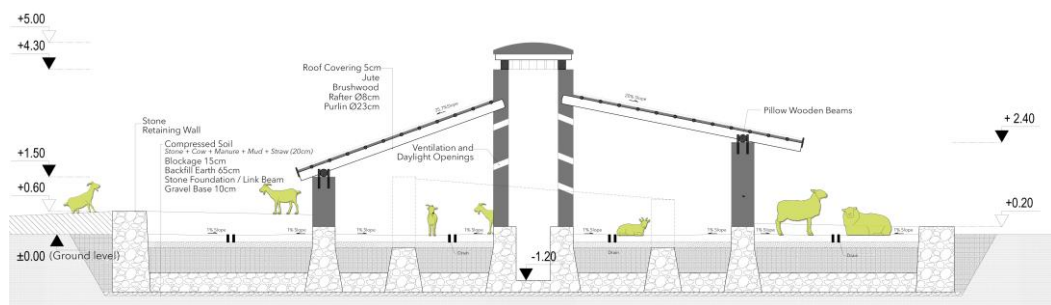
Figure 4. Section, *Dilara Demiralp, 2019*

The purlins and rafters of the roof that will cover the shelter are made of poplar wood. The coating is made of twigs, jute and covering materials and is detailed with a high degree of inclination against snow load. It is planned to make a non-hydraulic natural mortar using archaeological restoration techniques on the roof surface. Thus, a durable roof that will need less maintenance and high impermeability will be created. Floor purlins are placed instead of reinforced concrete beams where the purlins sit on curved earth walls. **(Figure 4)**

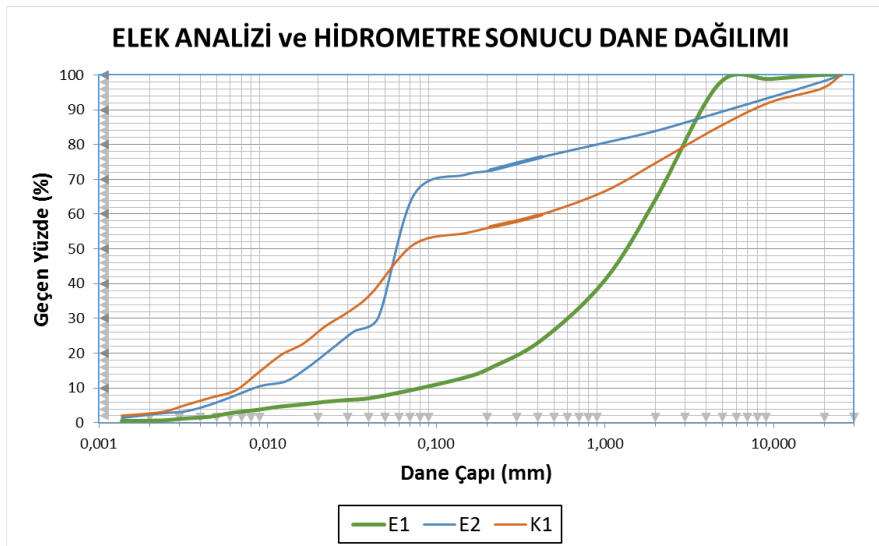
Table 2. Grain distribution as a result of Sieve Analysis and Hydrometer Measurements of E1, E2 and K1 Samples, *Istanbul Technical University, 11 September 2020*

In Palanga, Prof. Bilge Işık has determined the suitable points for earth alternatives. The soils extracted from the selected points were tested in ITU and Erzincan Binali Yıldırım University. The contents of the samples, consisting of gravel and sand, were determined by “sieve analysis”. (Table 1) and (Table 2) Consistency limits have been determined for universal nomenclature of samples with the combined soil class system.

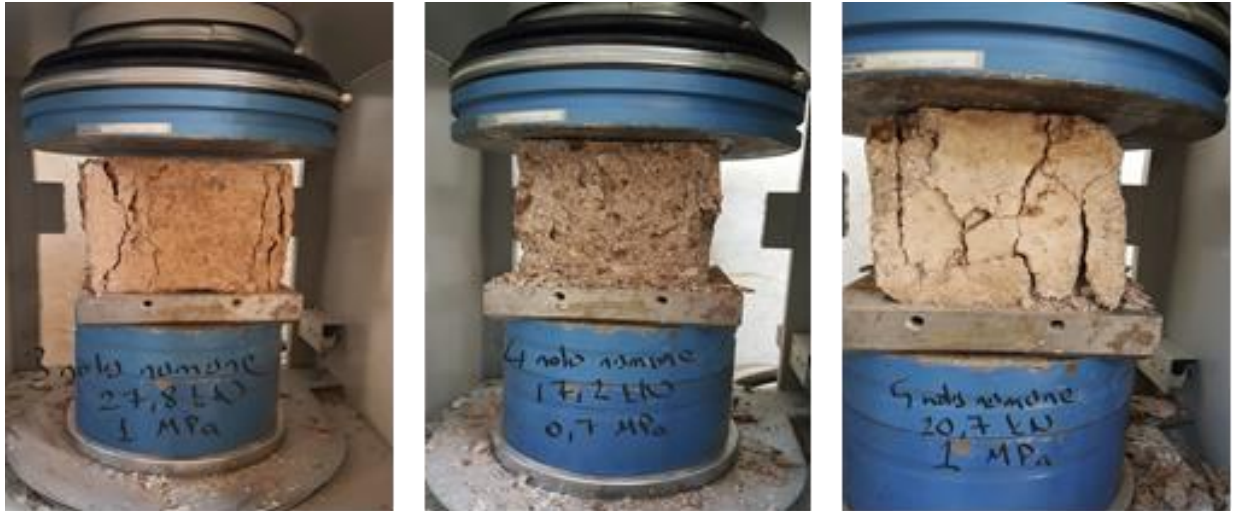
Figure 5. E1 soil sample (in the middle) was tested for compressive strength and passed, *Erzincan Binali Yıldırım University, 22 October 2020*

Excavated soil from the construction of the PAAF cattle facility, the E1 sample, performed best in these “sieve analysis” and “compressive strength” tests. (Figure 5) The soil to be chosen as a source must be devoid of organic components, rich in minerals. In addition, damage to agricultural lands must be avoided during the process. At this point, the first thing to do is to strip the first layer of soil rich in organic components and devoid of minerals to be used for agriculture. Layer underneath is needed.[5]

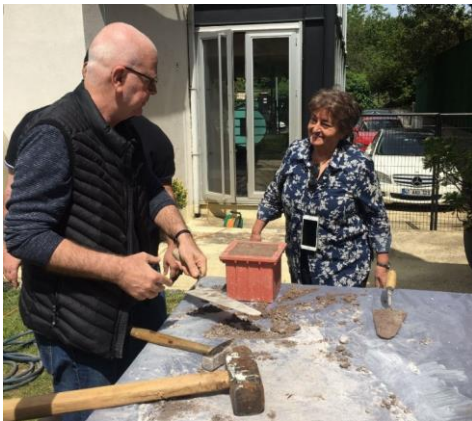
Figure 6. Rammed-Earth Workshop with the sample soils from Erzincan, 26 May 2021,
Participants: Prof. Dr. Bilge Işık, Suat Işık, Suat Güvenç, Dilara Demiralp

As of May 2021, construction process has begun with a workshop held in Istanbul with the consultants. **(Figure 10)** The soil mixture was prepared according to the following formula:
10% Gypsum + 5% Lime + Earth from Erzincan

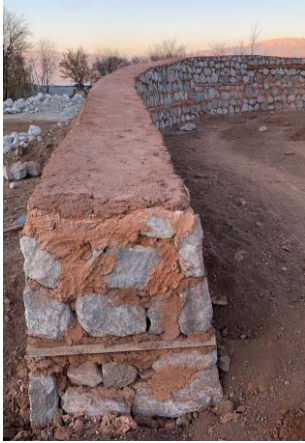
Figure 9. Retaining wall as a wind barrier with horizontal wooden beam inside, *December 2019*

The construction of the project started with the construction of stone foundation and retaining wall in the winter season of 2019. Due to the fact that Erzincan is an earthquake zone, the depth of the foundation reached 150 cm. **(Figure 7)**

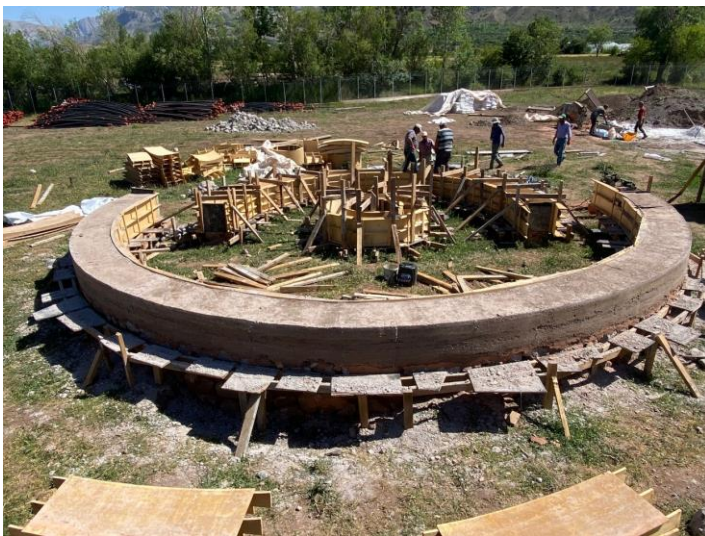
Figure 10. The first 60 cm of the two main earth walls were built., *10 June 2021*

According to the mixing ratios of the sample made in the workshop in Istanbul, a sample was made in Erzincan according to the following formula, **10% Gypsum + 5% Lime + Earth from Erzincan**, then the first 60 cm of the two main walls were built.

Expected results could not be obtained. Problems were detected in the bonding of the mortar due to ruptures and rapid drying on the wall surface.

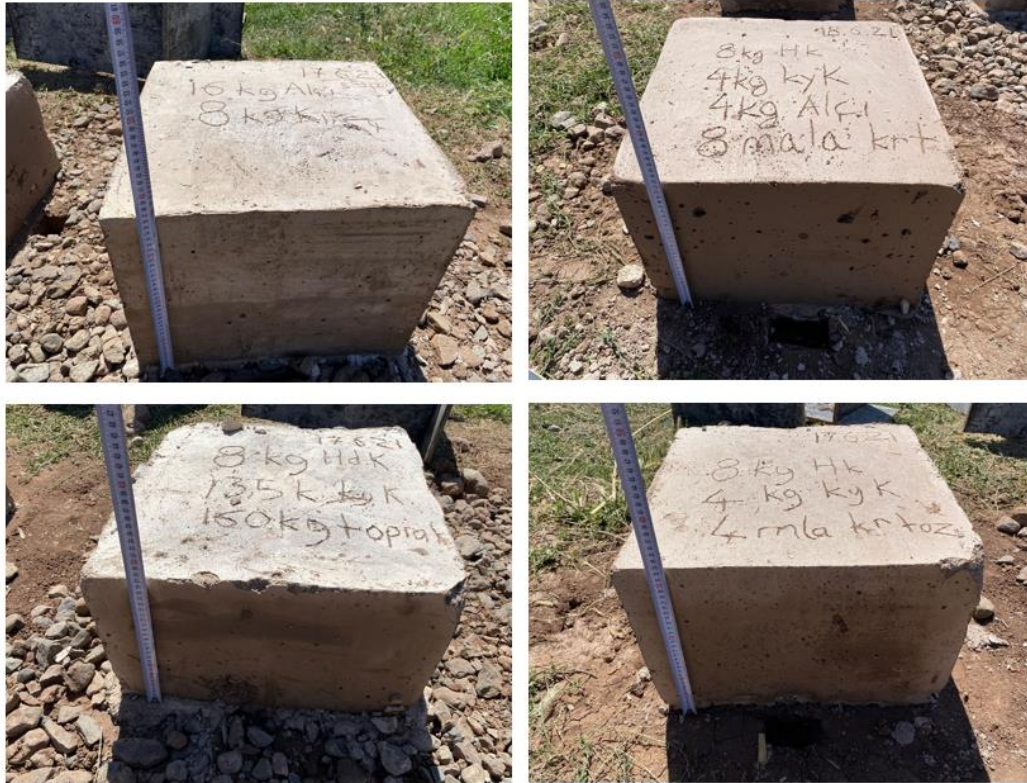
Figure 11. Soil mixture samples at different ratios were prepared and poured into the mold, 20 June 2021

Unlike the mixture in the workshop in Istanbul, a new formula was tried by considering the hot weather conditions and soil type in Erzurum. Since gypsum is a material that absorbs water, it was removed from the mortar. There are breaks and cracks in the surface.

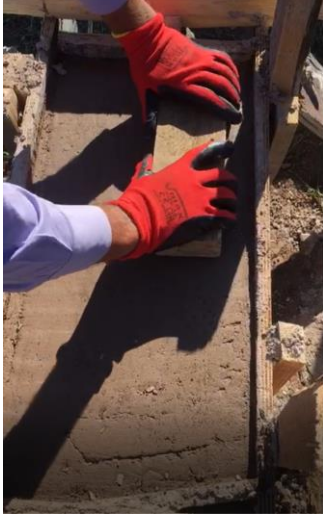
Figure 12. The earth wall mortar was prepared and applied gypsum additive, *30 June 2021*

Considering these studies [7] shared by Mustafa Çakalgöz; During the casting process, hydraulic lime, cream lime and tile powder were added to prolong the drying time and increase water resistance. The mortar was prepared according to the following formula:

16 kg Hydraulic lime + 14 kg cream lime + 150 dm³ Earth + 12 kg tile powder

- 1- Mix tile dust and soil (45 shovels) for 5-10 minutes
- 2- Add hydraulic lime and mix for another 10 minutes
- 3- Add cream lime
- 4- Add water until you get the consistency of mud

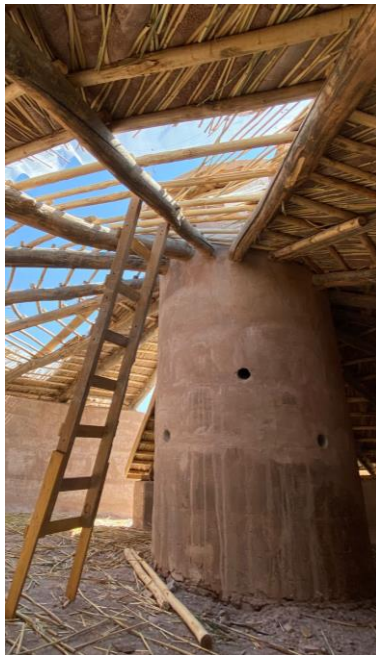
Figure 13. The rammed-earth central column with the openings on the surface, *31 August 2021*

Essence of the historical design with the opening on the top is that the building functions like an atrium, and the opening modifies the indoor climate passively. It gives the user orientation in the space and focuses to bring them together. Also, it creates the smoke escape of the fire place in the center. [6] The rammed-earth column in the center where the purlins are set is also designed to function as a chimney that facilitates the discharge of the methane and gas accumulated in the space, openings on the surface large enough to not reduce the static strength of the overall structure (**Figure 13**).

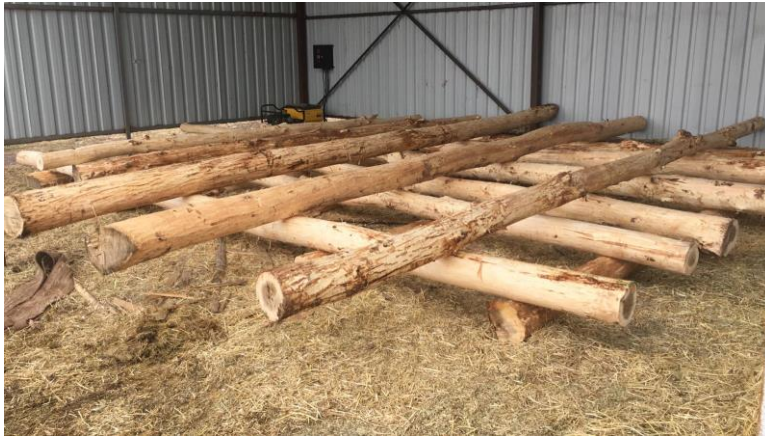
Figure 13. Timber drying technique, *October 2019*

The purlins and rafters of the roof that will cover the shelter were obtained from the poplar trees in the region. Purlins with an average diameter of 23 cm were covered with rafters with a diameter of 8 cm. Poplars were dried for a long time (19 months) with the timber drying technique, as the construction was suspended during the pandemic. It has been cleared of its bark by the timber drying method without being subjected to chemical treatment and made ready to turn into purlins that would form the structure (**Figure 13**). After the wall construction was completed, the roof purlins began to be placed on the wall (**Figure 14**). The piles, which were burned with a blowtorch, were left in the drying wall and pillow wooden beams were used to connect the purlins with the wall and were connected to each other with nailed wires (**Figure 15**). The form of the roof, which will cover the semi-circular walls of which slopes change, also consists of variable slopes. Curvilinear artificial topography is made behind the shelter to protect goats, roof and walls from being exposed to the wind.

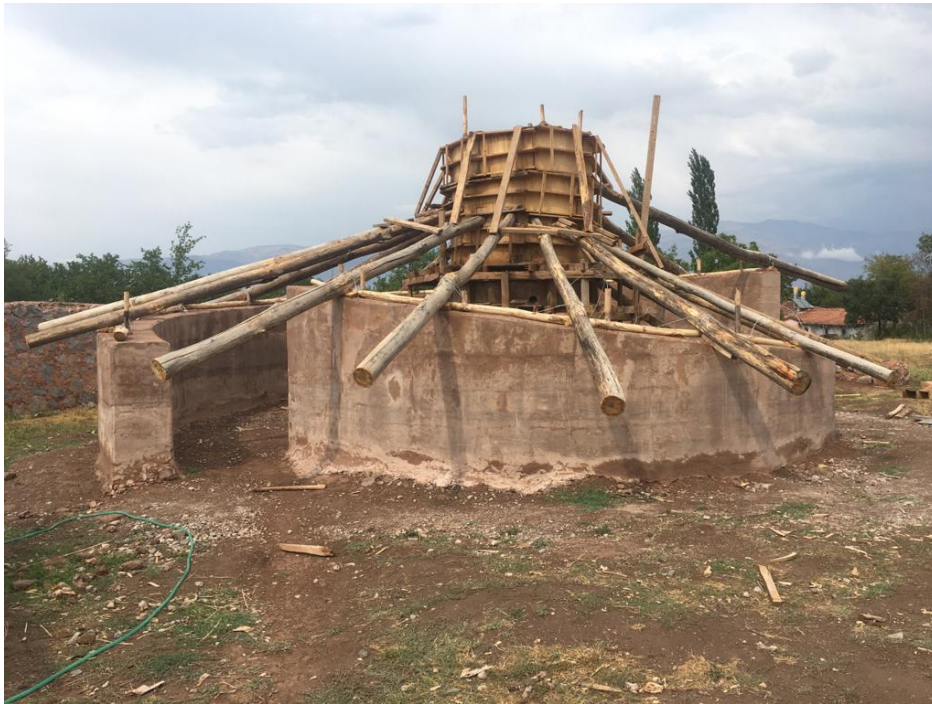
Figure 14. All poplar purlins were carried by the central earth column and attached to certain points on the semi-circle earth walls, *27 June 2021*

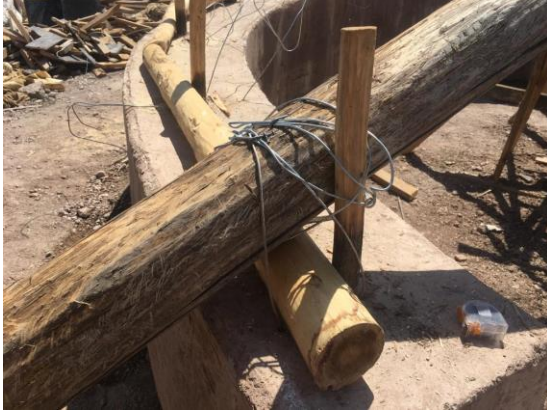
Figure 15. Poplar purlins and pillow wooden beams joint detail, 27 June 2021

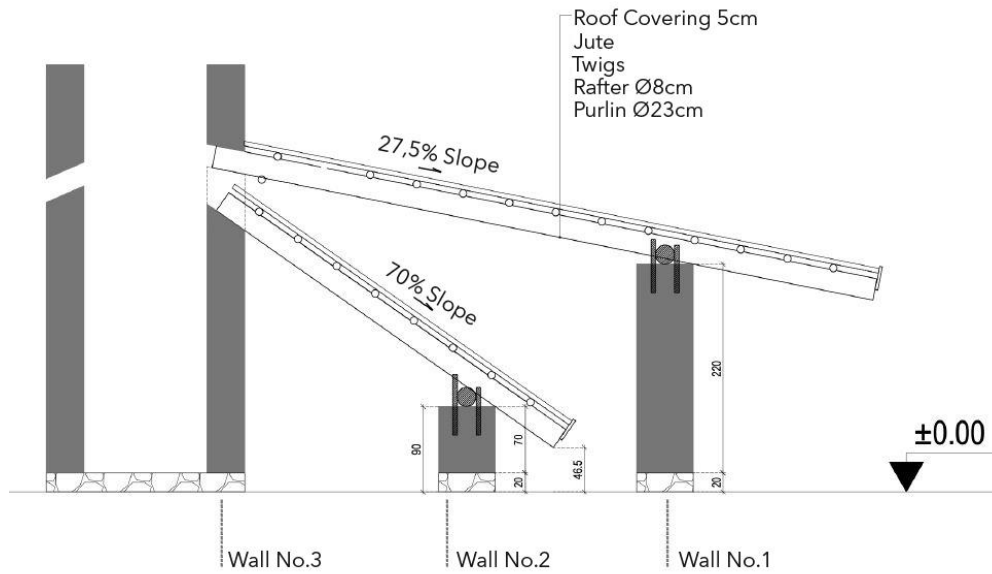
Figure 16. Variable slopes of roof, *Dilara Demiralp, 2019*

The form of the roof, which will cover the semi-circular walls of which slopes change, also consists of variable slopes (**Figure 20**). A maintenance-free roof finish material was needed to find that could work in harmony with these slope grades, was resistant to climatic conditions and the movement of goats on it. The coating is made of twigs, jute and covering materials.

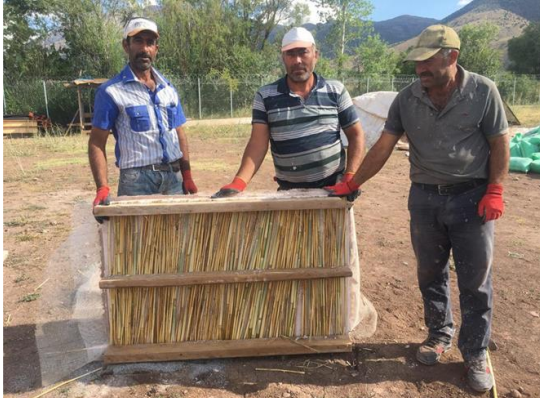
Figure 17. Samples prepared for roofing mix, 16 July 2021

The mortar which was prepared based on archeological restoration technique, has created a waterproof, maintenance-free, long-lasting roof layer. There is no soil in the mortar. The roof covering mortar was prepared according to the following formula:

5 units of Hydraulic Lime
2.5 units of Cream Lime
1.5 units of Perlite Sand
2.5 units of Tile Powder

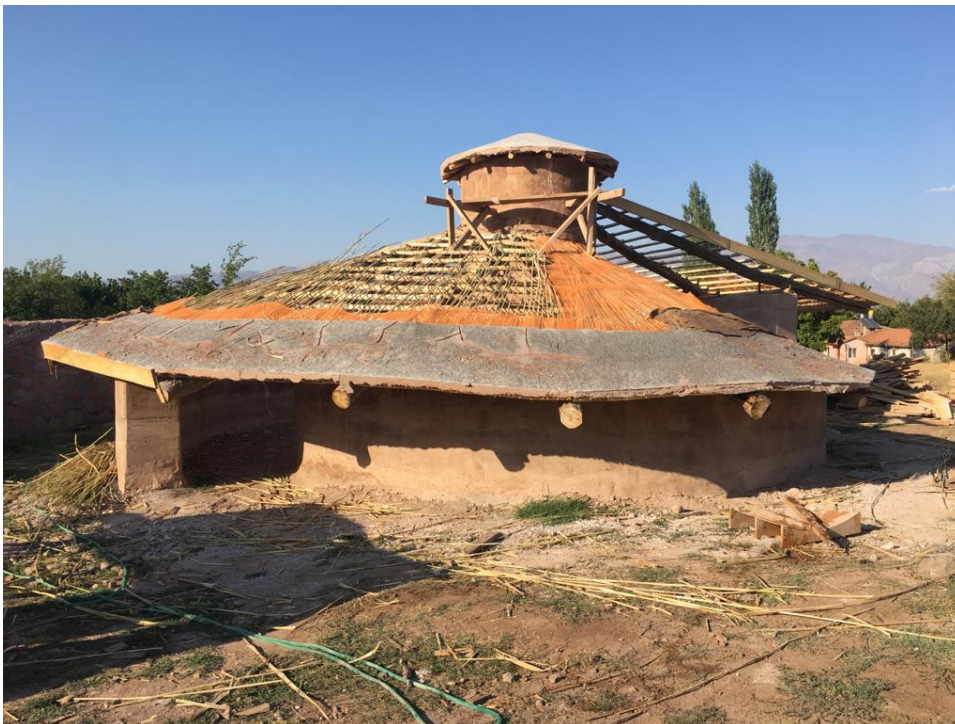
Figure 18. Layers visible during roofing, 31 August 2021

The reed grass was laid on the rafters. A plaster net placed over the reed grass. Then, the mortar for the roof poured on top of them. Perlite was sprinkled on the top surface to make it hardened (**Figure 18**)
