Understanding the change in construction technology of traditional vernacular buildings of Dhulikhel.

Buddha Shrestha, Ramesh Adhikari, Santosh Chaudhary
Kathmandu University, Nepal
buddha.shrestha@ku.edu.np

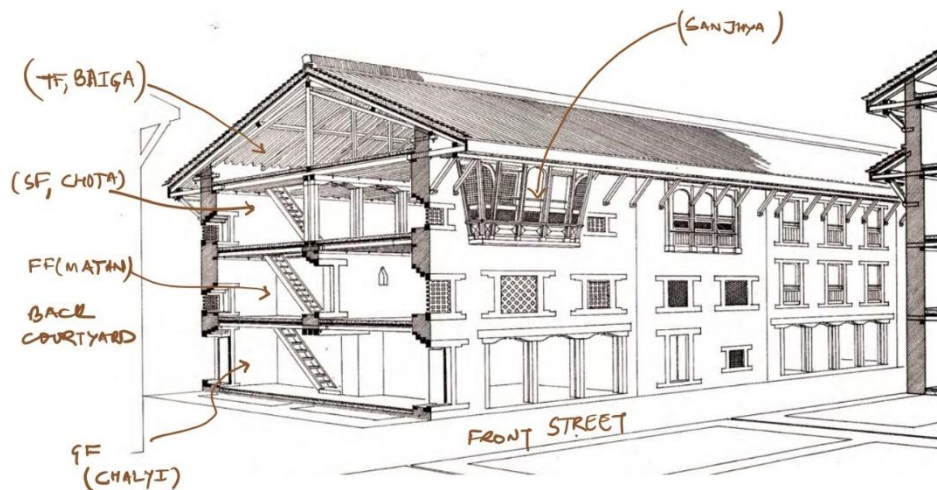
Figure 3. Sketch showing standard accomodation

This rectangular newari house is divided into two bays by a middle spine wall parallel to the longer side. The rows of wooden columns frequently replace the part of the front wall, opening the ground floor to the street (Fig. 3). The back rooms are a storage room, workshop etc open to the courtyard. The ground floor is known as Chayali.

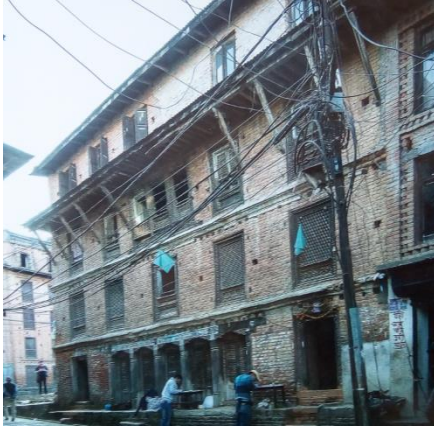
Figure 4. Traditional building for study.

A building (Fig. 4) located in the core of the traditional settlement is chosen to conduct this study. This building is chosen because it is more than 50 years old, and the architectural characteristics seem quite intact in the facade and planning well except some remarkable changes in the top storey. This building represents common building typology of that period which undergoes some changes later to accommodate modern facilities and requirements. The digitized replica shown in Fig. 5 represents the original form of the studied building.

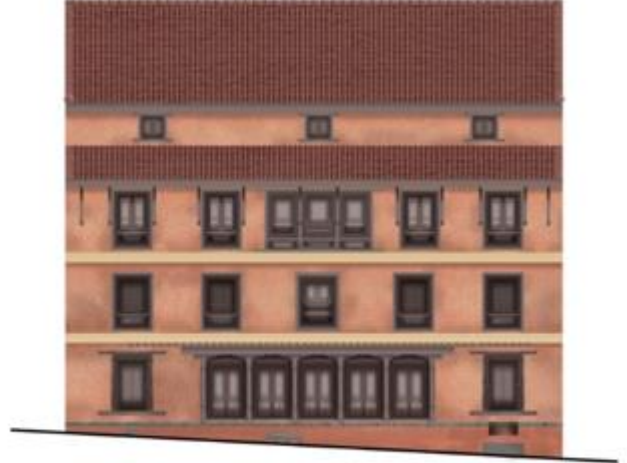
Figure 5. Replica image of studied building.
